# Washburn-Fair Oaks Historic District Design Guidelines

Prepared for the Minneapolis Heritage Preservation Commission  
City of Minneapolis  
Department of Community Planning and Economic Development (CPED)

Prepared by  
Pigeon Consulting, CPED, and Ten x Ten

Adopted June 18, 2024

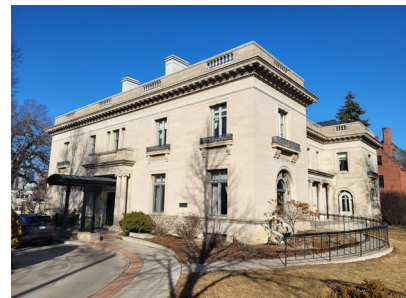
*The Gale Mansion at 2115 Stevens Ave is a good example of Italian Renaissance Revival architecture. The stone columns, arched windows, and decorative cornice are part of its historic character.*

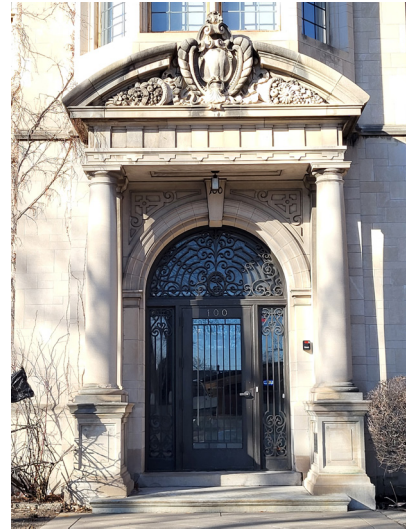
*This stone entry at 100 22nd St E is a distinctive historic feature. The pediment above the door has carvings of fruits and flowers.*

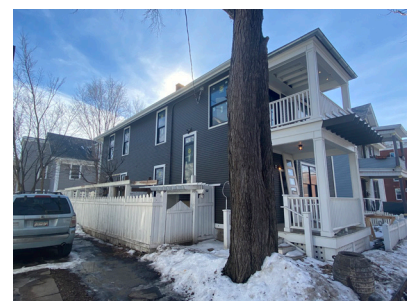
*105 25th St E in 2022. This house was built in 1908 and is a contributing resource. Note how the front porch has changed since the 1980s. The porch is one of its non-historic features.*

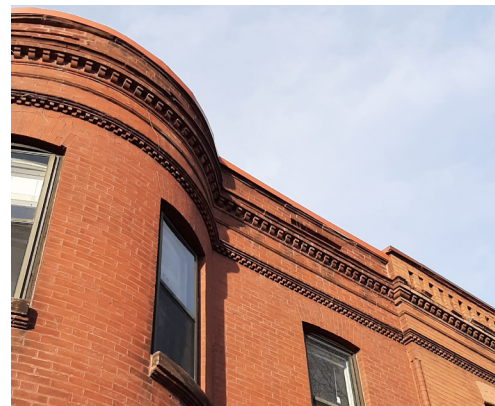
*Note the historic brickwork at 100 25th St E. These rowhouses have brick dentils and brackets along the cornice line.*

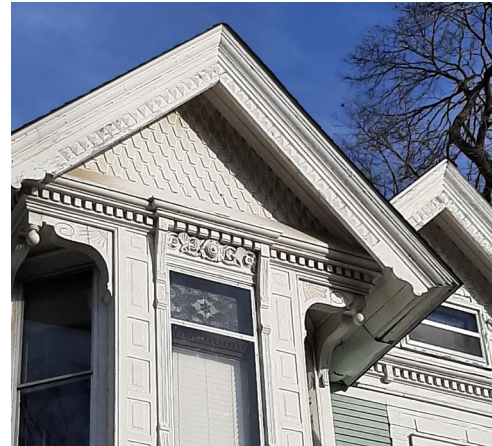
*The house at 2429 1st Ave S has many historic wood features. The green lap siding, paneled trim around the windows, and shaped shingles in the gable ends are all original. The gables also have a row of dentils, bargeboards along the eaves, and scroll brackets in the overhang.*

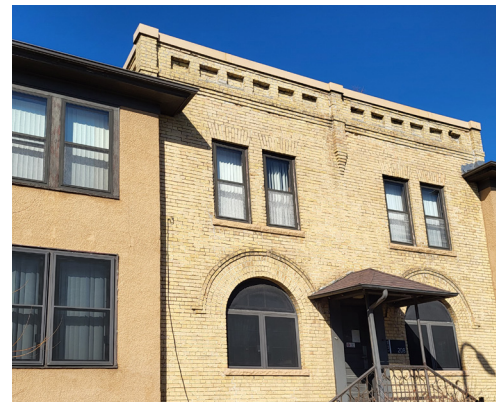
*The storm windows at 206, 208, and 210 26th St E are pre-finished metal. Storm windows help retain heat inside the building.*

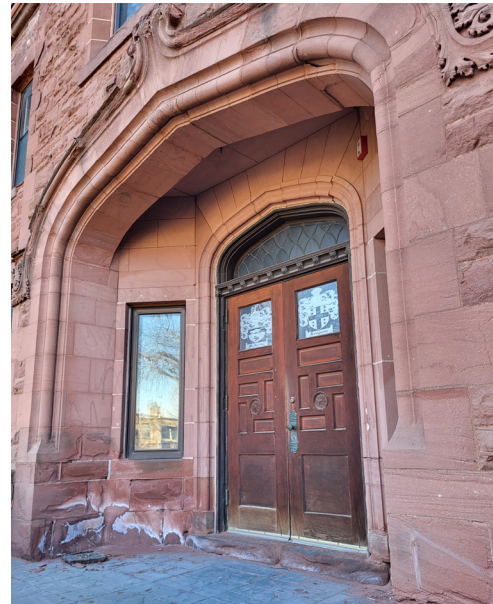
*The historic wood door is present at 2116 2nd Ave S. It has a decorative frame and a leaded transom window above. It is important to preserve these features.*

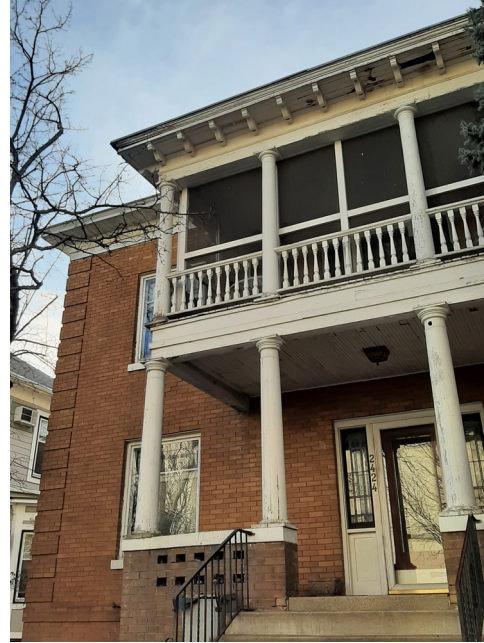
*This two-story porch at 2424 Stevens Ave has historic architectural details that should be retained. Wood Tuscan columns support the structure. Turned wood railings line the second story.*

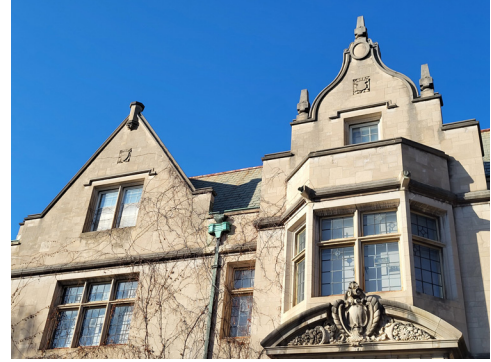
*The house at 100 22nd St E has several historic roof features. The roof is covered with slate. The gutters are built into the roof. Stone parapets extend up from the roof. The one on the left is pointed. The one on the right is stepped and scalloped with carved finials.*

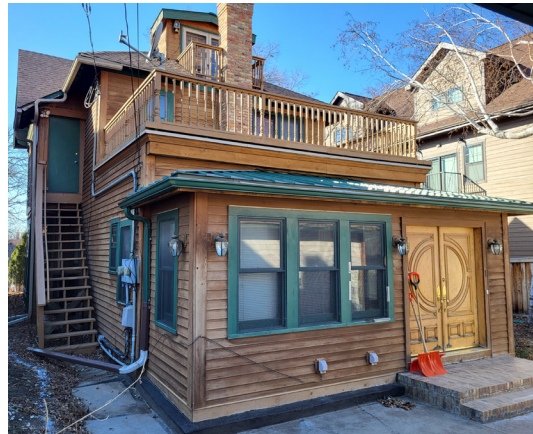
*At 2417 1st Ave S, there is a one-story rear addition, built in 2003. It is smaller than the original building. The roof shape and material differ from the original building. The window pattern is contemporary and still compatible.*

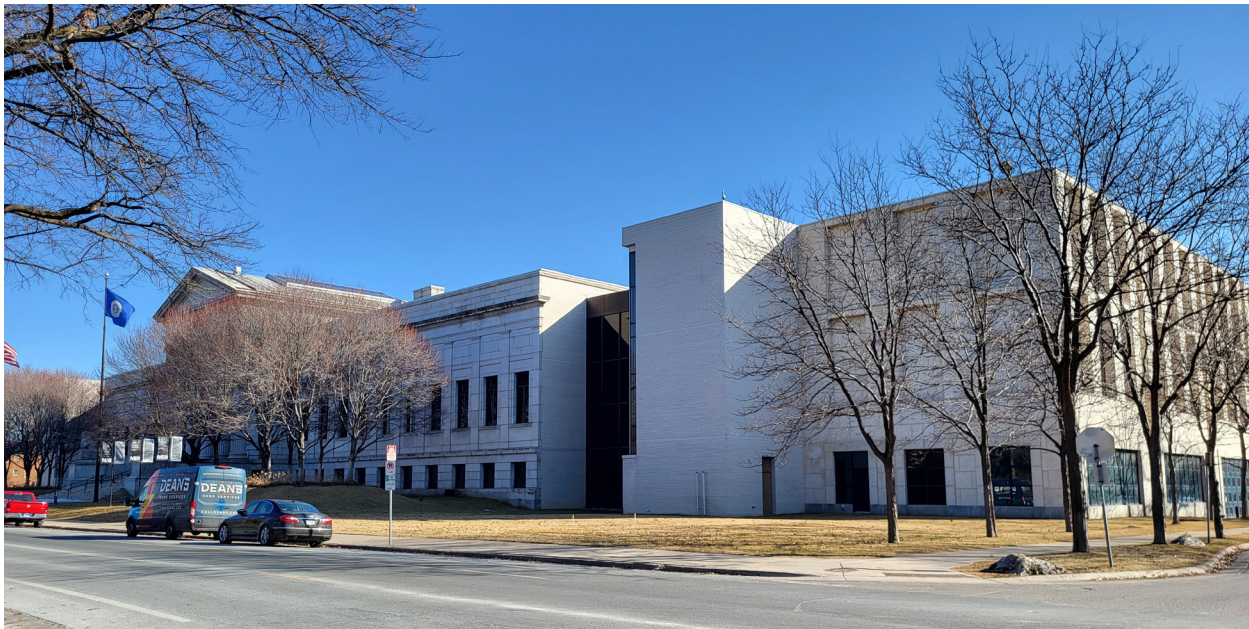
*The original building for the Minneapolis Institute of Art (MIA) is shown at left. It was designed by the prominent architectural firm McKim, Mead, & White. Michael Graves designed a contemporary addition at right. The original building was finished in 1915 and the addition opened in 2006. The addition does not copy the design of the historic building.*

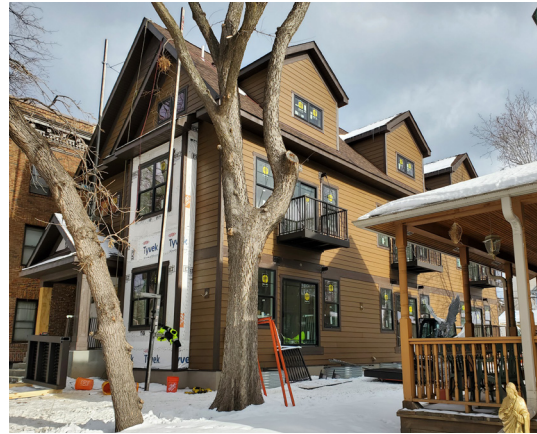
*The house at 2413 1st Ave S was built in 2022 and is compatible with the historic district. Its main entrance faces the street. It is 2.5 stories tall and aligns with the neighboring buildings.*

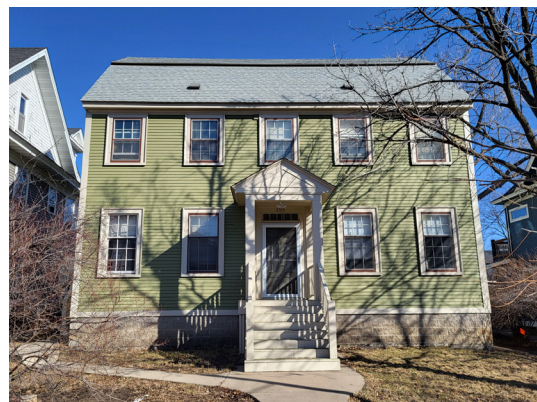
*Built in 1998, the house at 2515 1st Ave S has a masonry foundation and one cladding material. The windows have divided lights.*

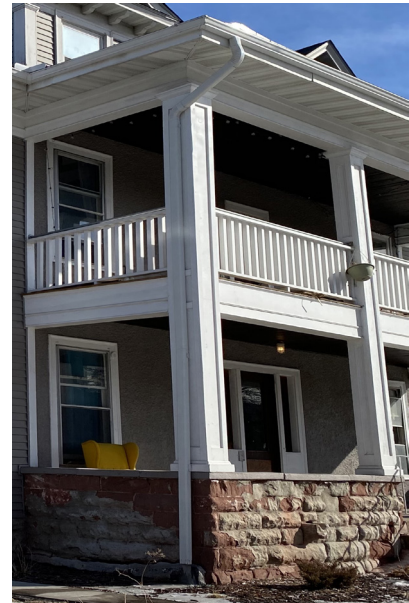
*The square railing posts at 2511 1st Ave S are simple and do not mimic historic designs.*

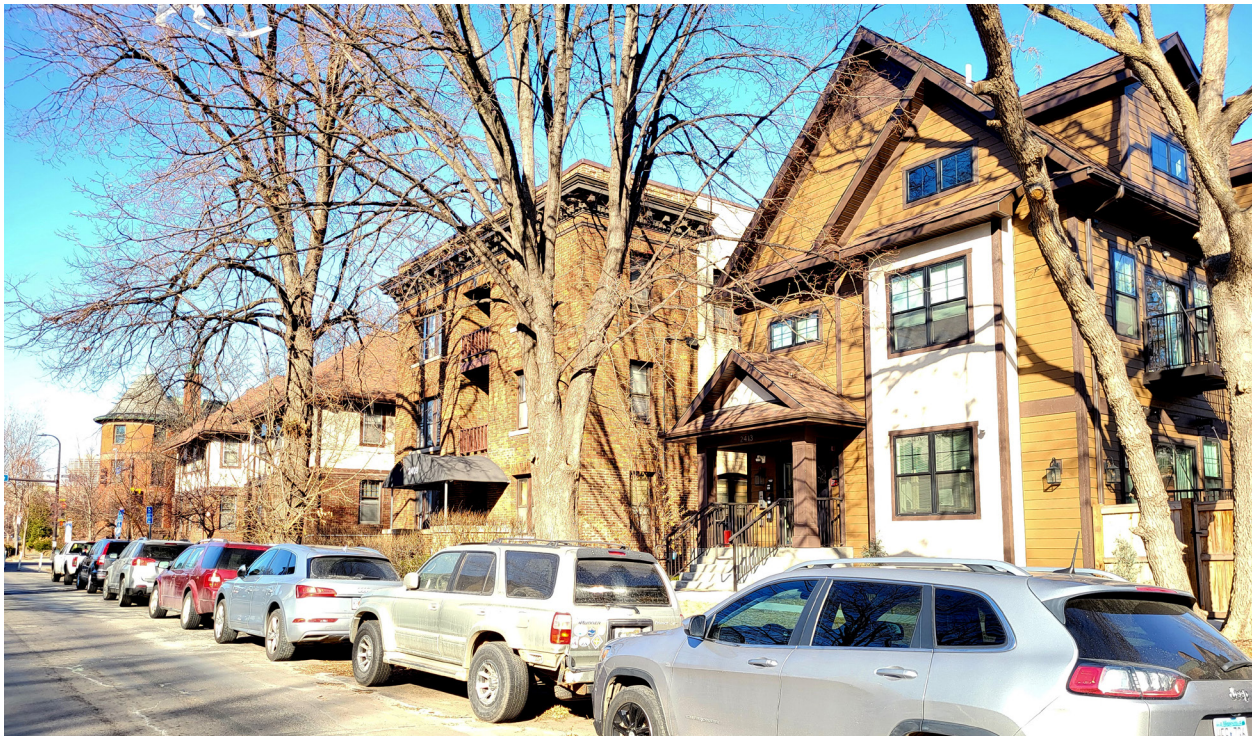
*View of 1st Ave S between 24th St E and 25th St E. The building at 2413 1st Ave S (at right) is an example of compatible new construction. It fits with the character of the historic buildings to the left.*

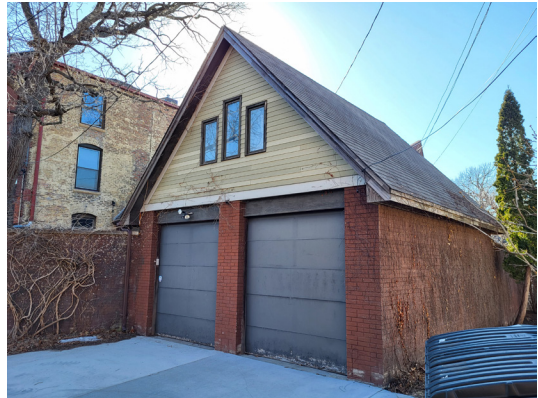
*This garage at 108 24th St E uses materials that are appropriate in this district. The walls are clad in brick and lapped siding. The windows are wood and the roof has asphalt shingles.*

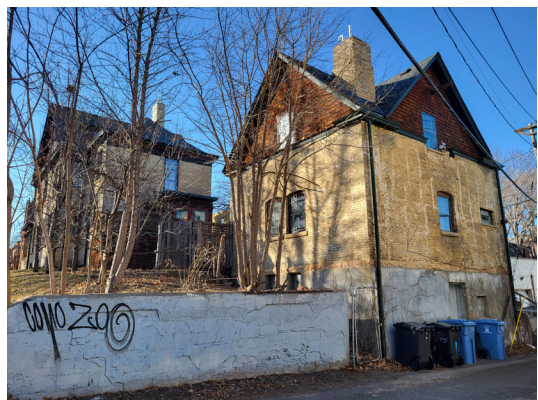
*This accessory building (right) was constructed in 1899 as a barn for the main house (left) at 2117 2nd Ave S. It retains its historic wall cladding, which matches the main house.*

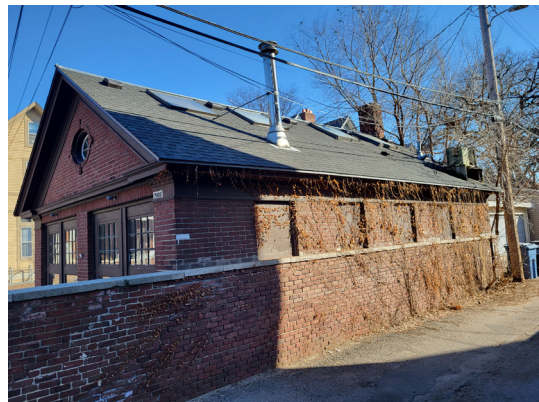
*This carriage house at 2404 Stevens Ave has modern skylights and HVAC equipment on its rear roof slope. This location is not visible from the street.*

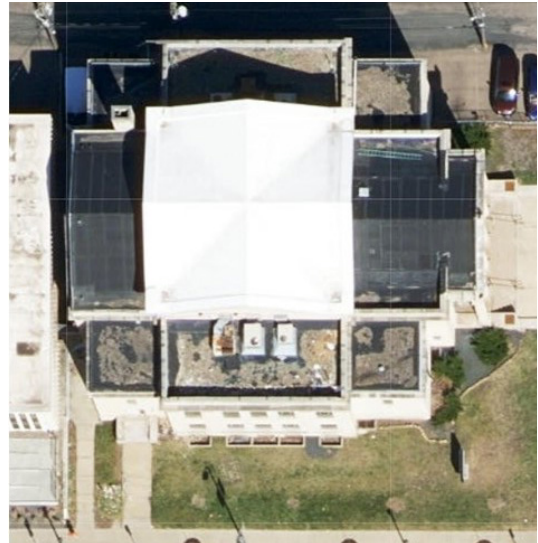
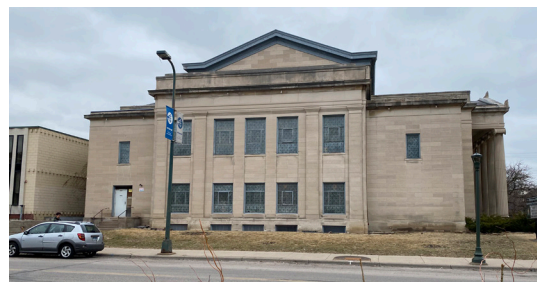
*This is the Minneapolis First Seventh-day Adventist Church at 4 24th St E. On the bottom is a view of the west elevation. On the top is an aerial view (Courtesy of MinneAtlas).*

*The rooftop mechanical equipment is set back significantly. The rooftop units are not visible from the street.*

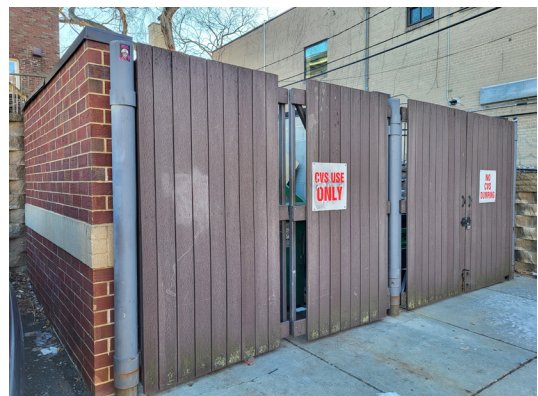
*The trash enclosure at 15 Franklin Ave E is simple. It uses brick and wood pickets.*
